# Manhole Inspection Summary

Manhole # S25E\_\_028MH

Insp Date: **8/9/07 10:20 AM**

**Location** Address: **1301 SARATOGA ST**

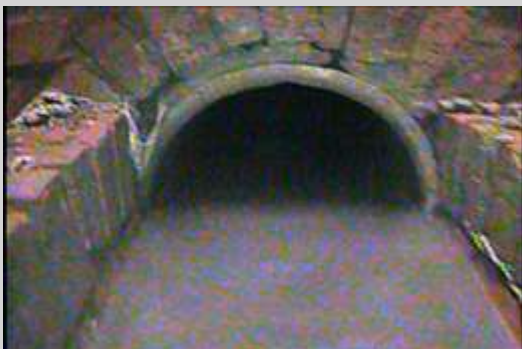
3 O'Clock Inflow

8 in. Circular Gravity Sewer  
Pipe In @ 3 O'Clock

Pipe Height: **10.8** (in.) Rod and Bar (Angled)  
Pipe Material: **Clay** ☐ Pipe Lined  
Invert Depth: **9.89** (ft.) Flow Characteristics: **Slow**  
Deposits: ☒ None ☐ Mud ☐ Sludge ☐ **Debris** ☐ Grease  
Silt Depth: (in.) Deposits Extent:  
Infiltration: **None** Pipe Seal Cond: **Sound**
